SECTION VI

CASE STUDIES

**Neal A. Vogel
Project Director**

PROTECTIVE GLAZING CASE STUDY #1

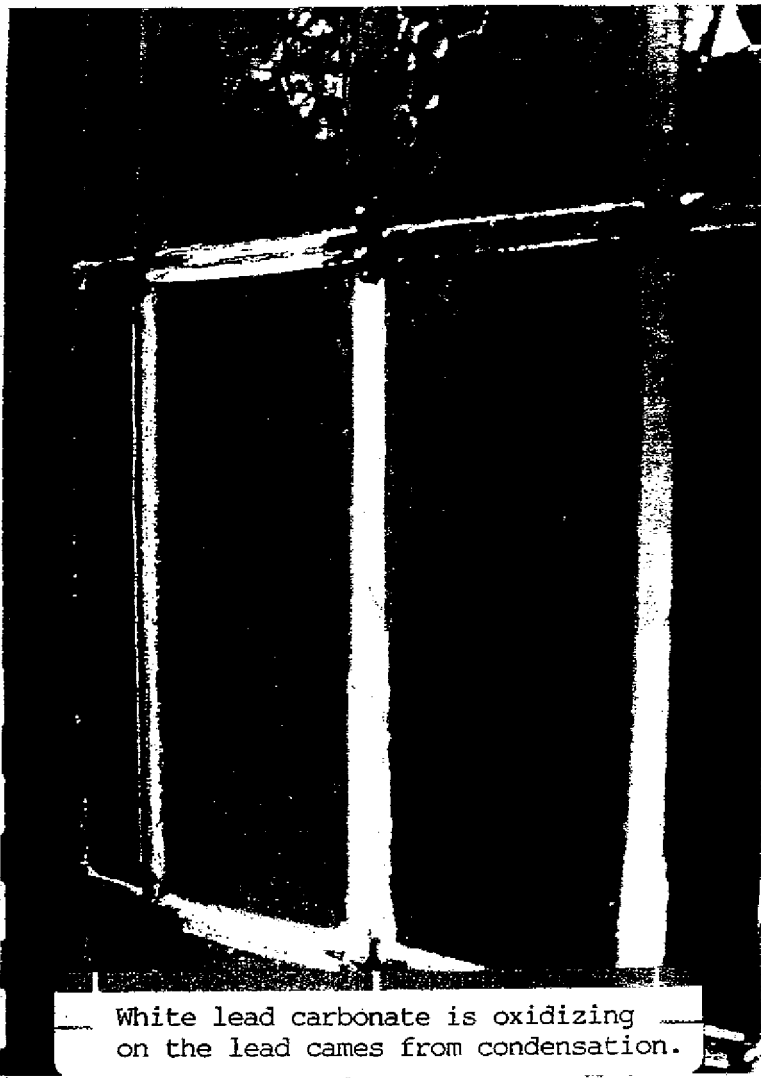
White lead carbonate is oxidizing on the lead comes from condensation.

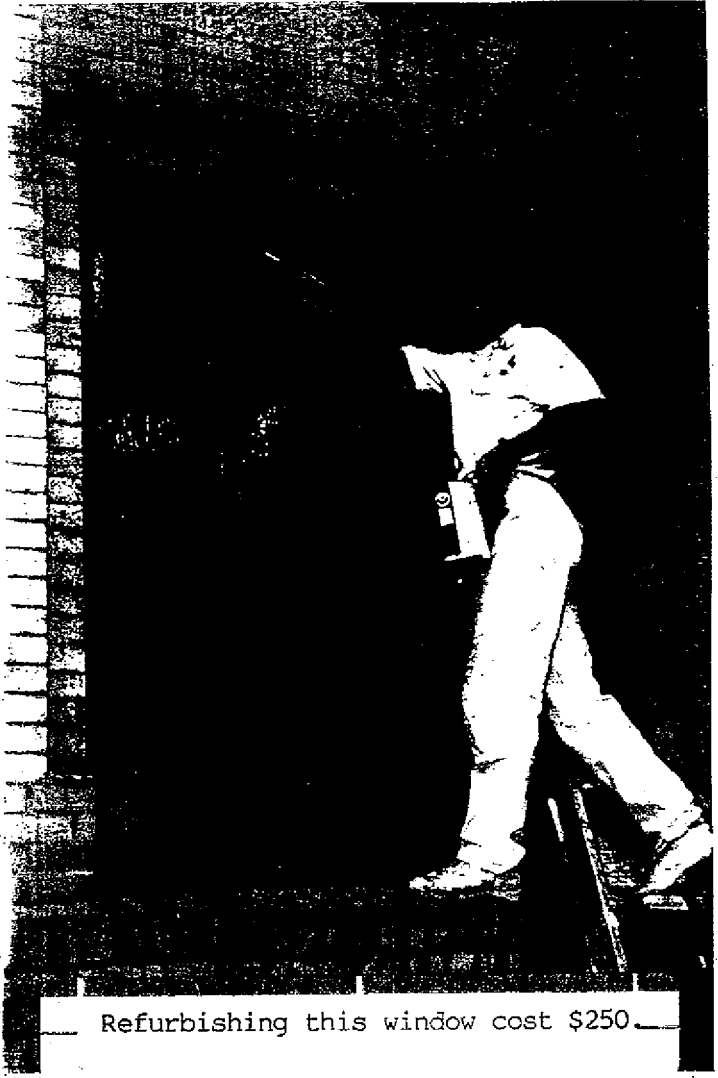
Refurbishing this window cost \$250.

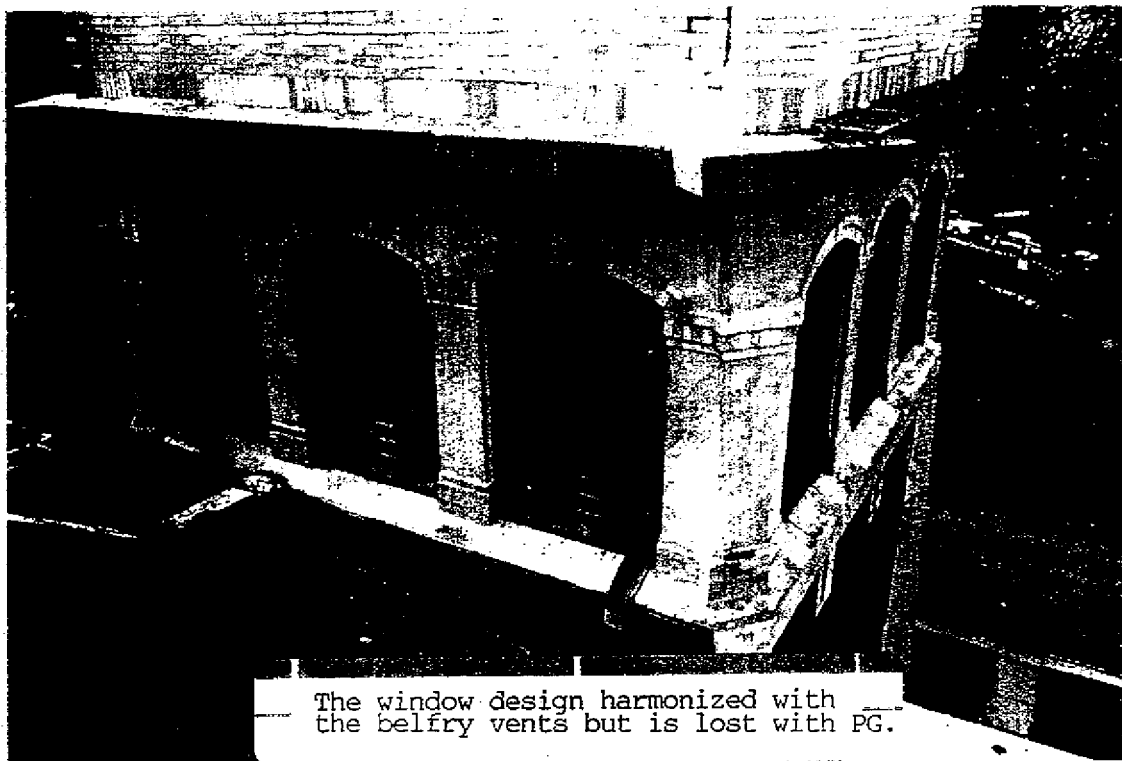
The window design harmonized with the belfry vents but is lost with PG.

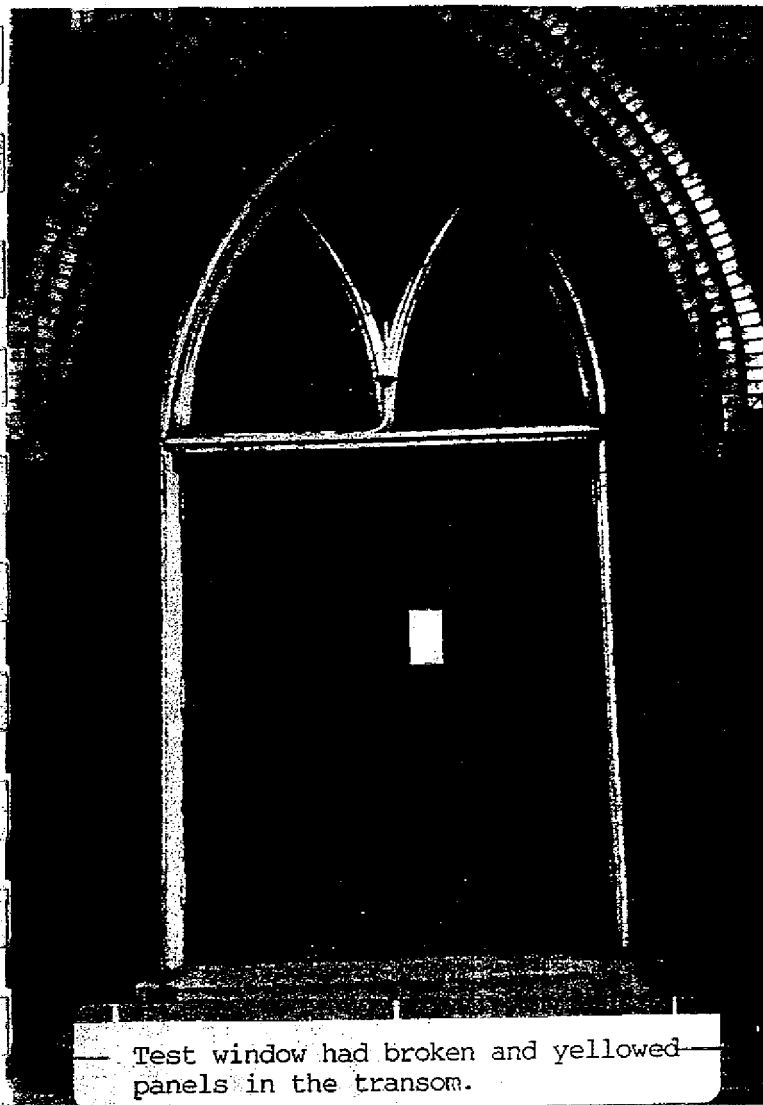
Test window had broken and yellowed panels in the transom.

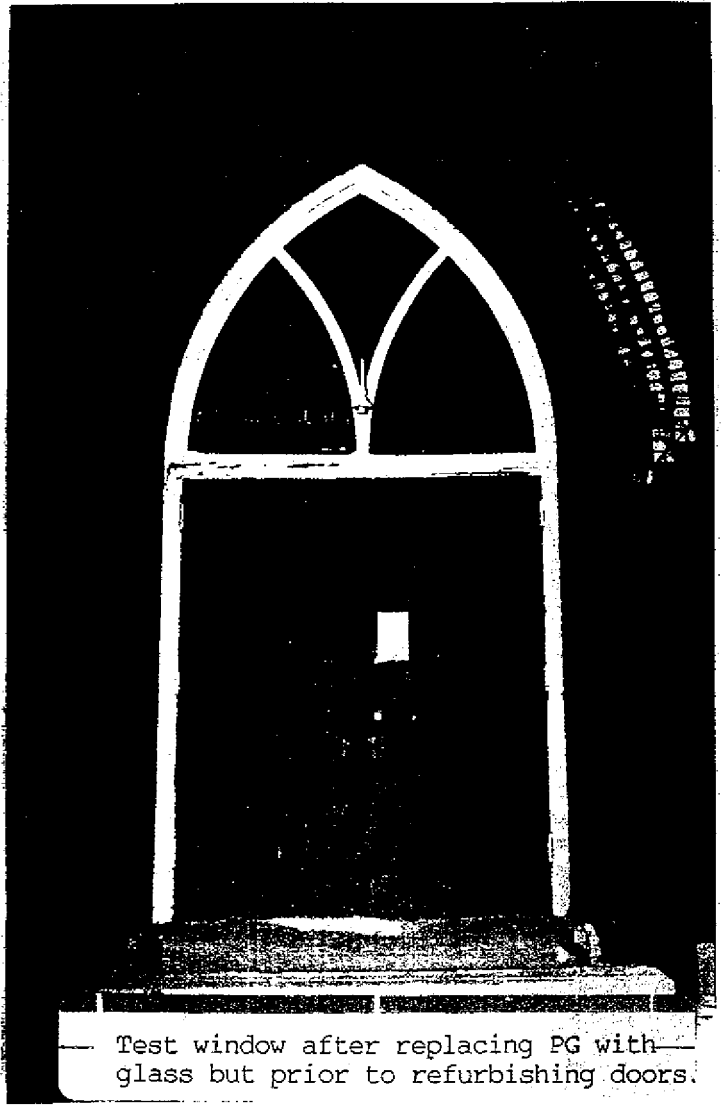
Test window after replacing PG with glass but prior to refurbishing doors.

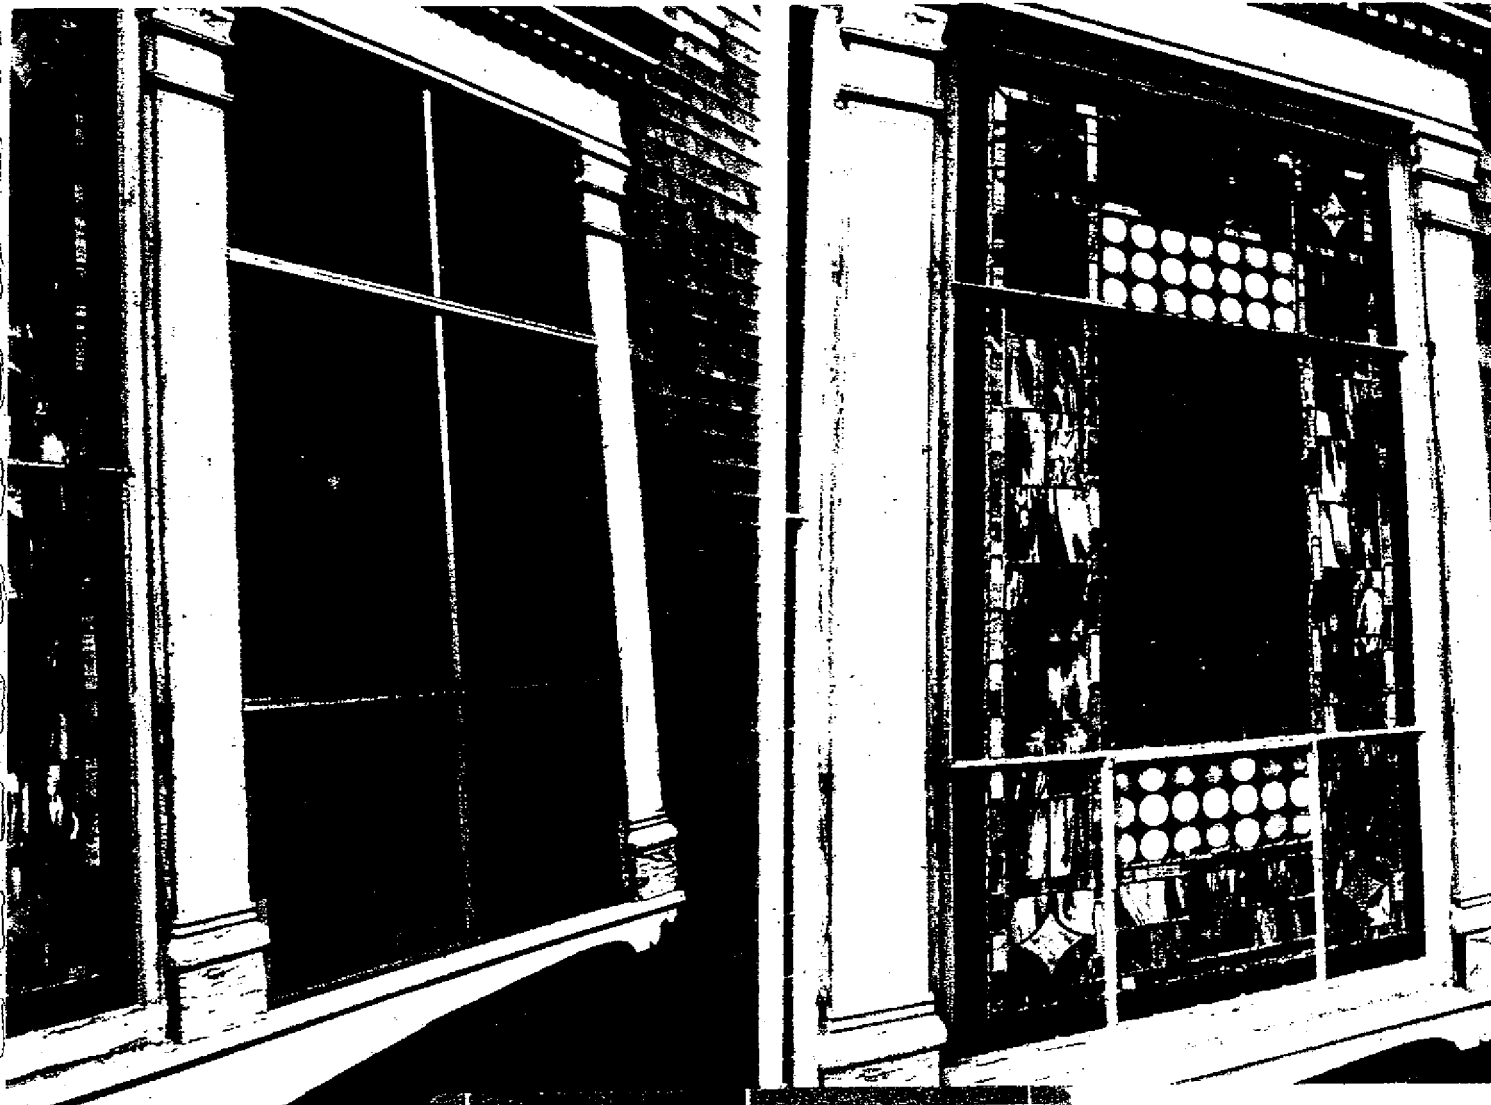
Removal of the hazed PG revealed the brightly colored glass behind.

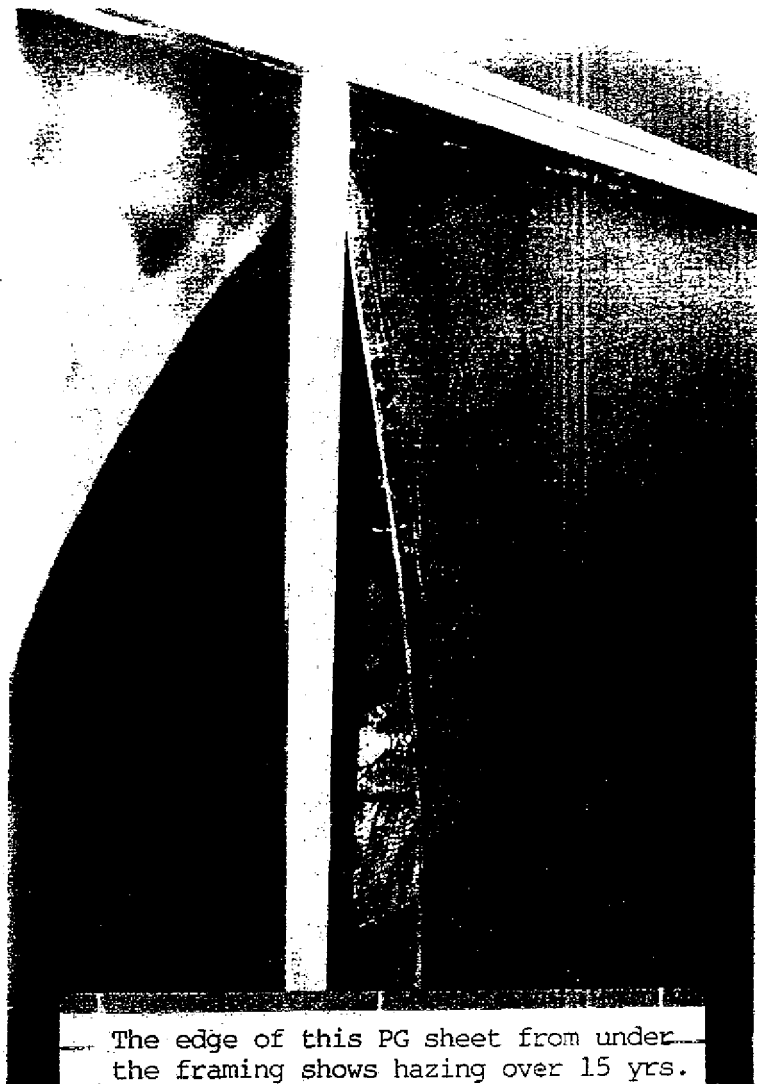
The edge of this PG sheet from under the framing shows hazing over 15 yrs.

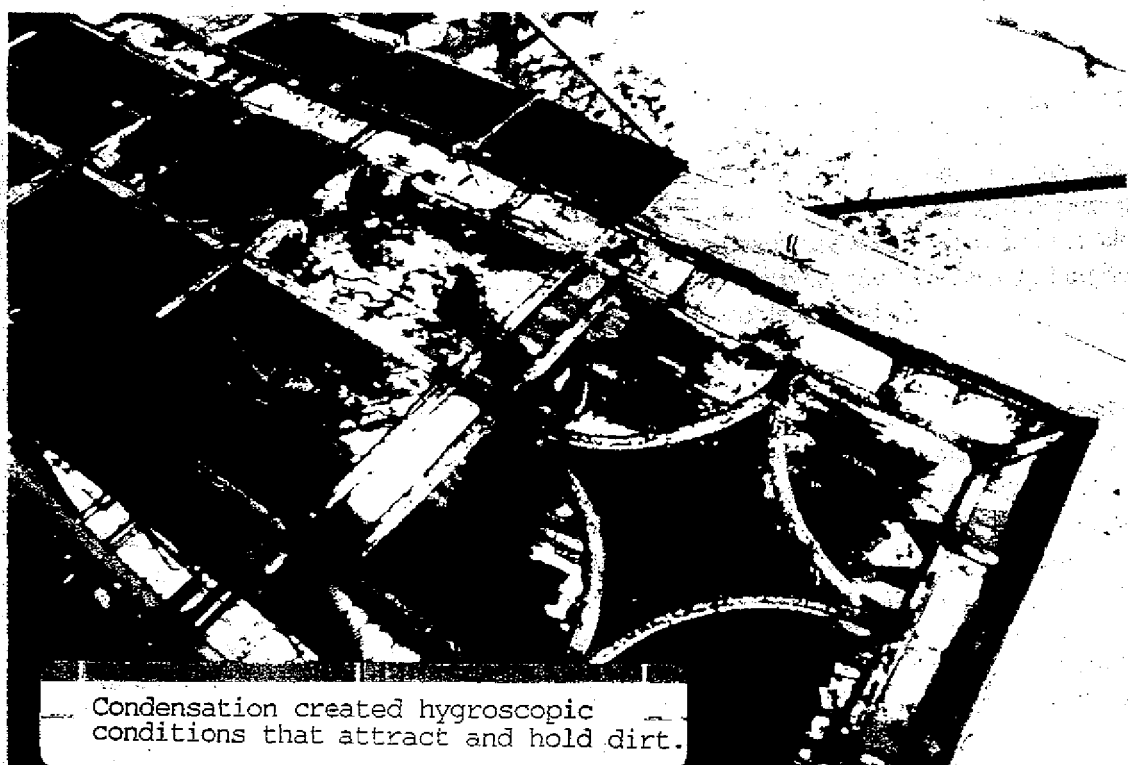
Condensation created hygroscopic conditions that attract and hold dirt.

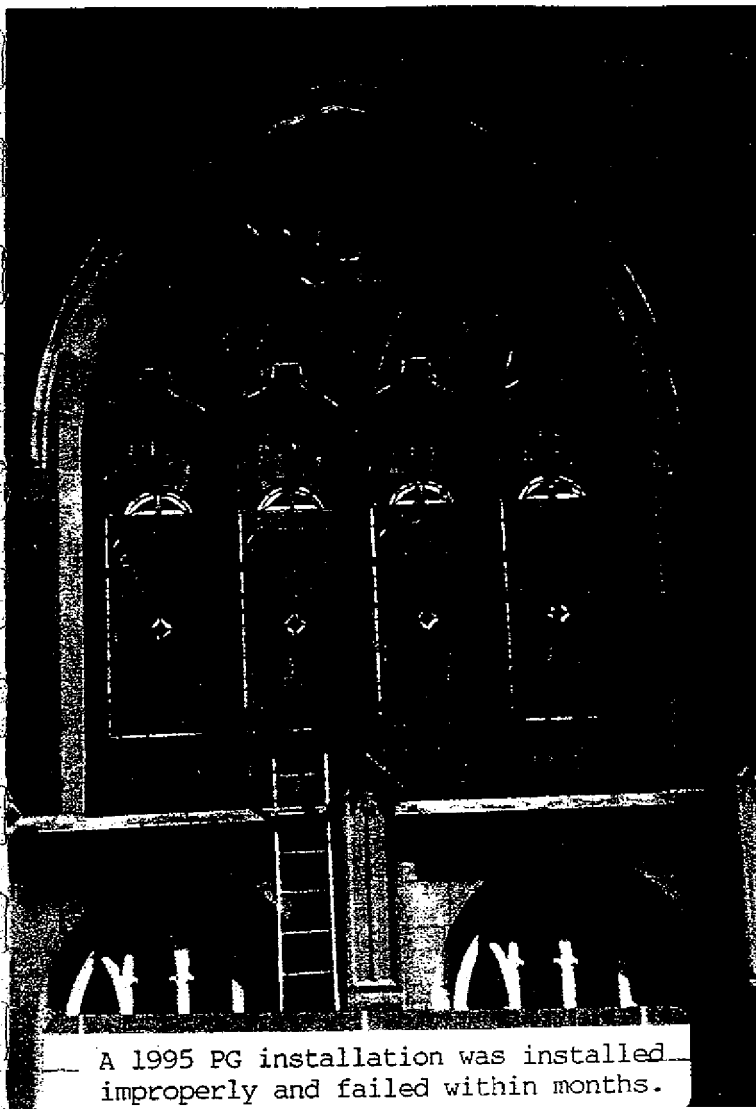
A 1995 PG installation was installed improperly and failed within months.

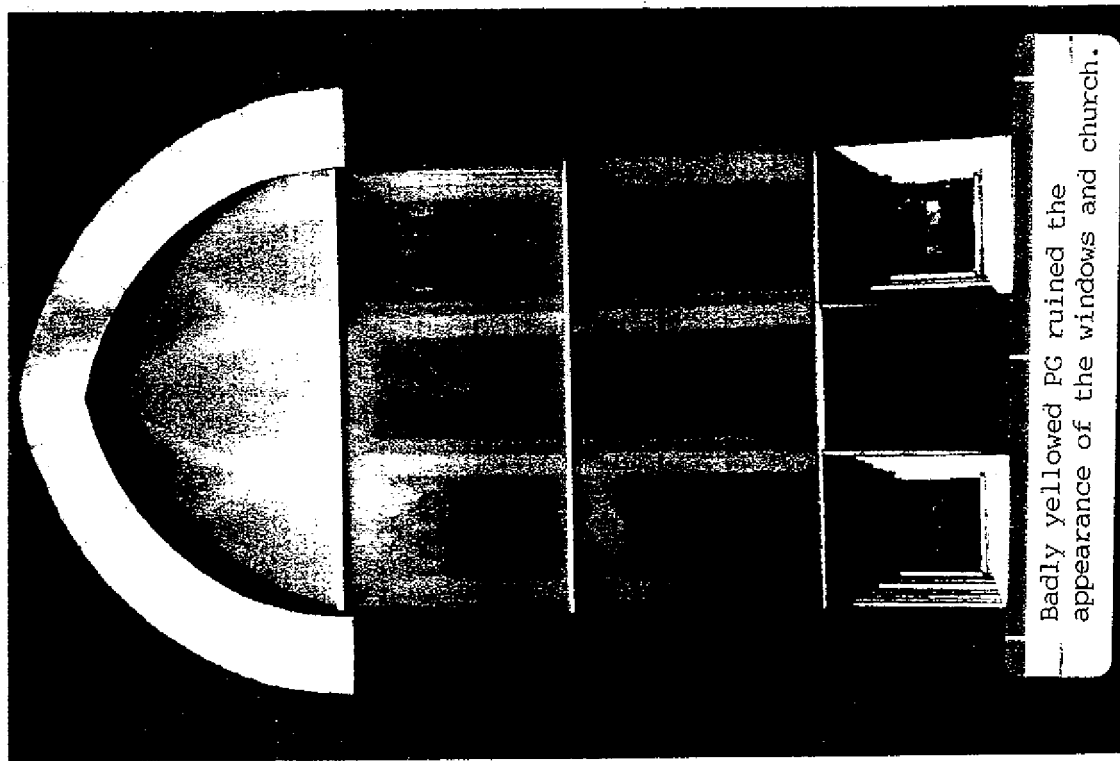
Badly yellowed PG ruined the appearance of the windows and church.

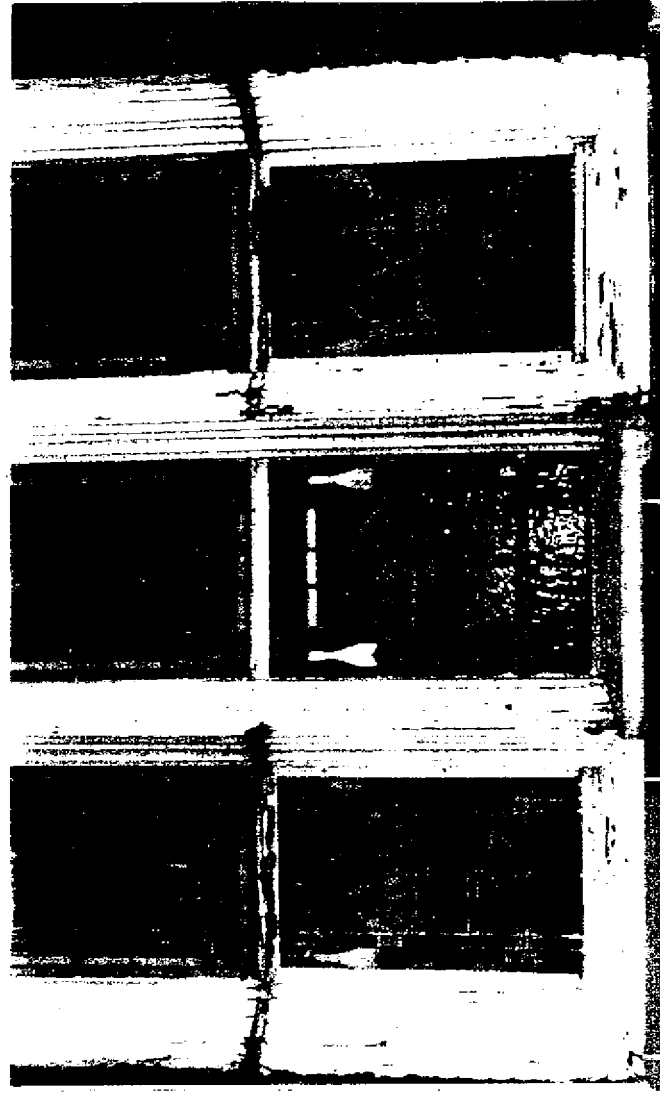
PG finally causes condensation that

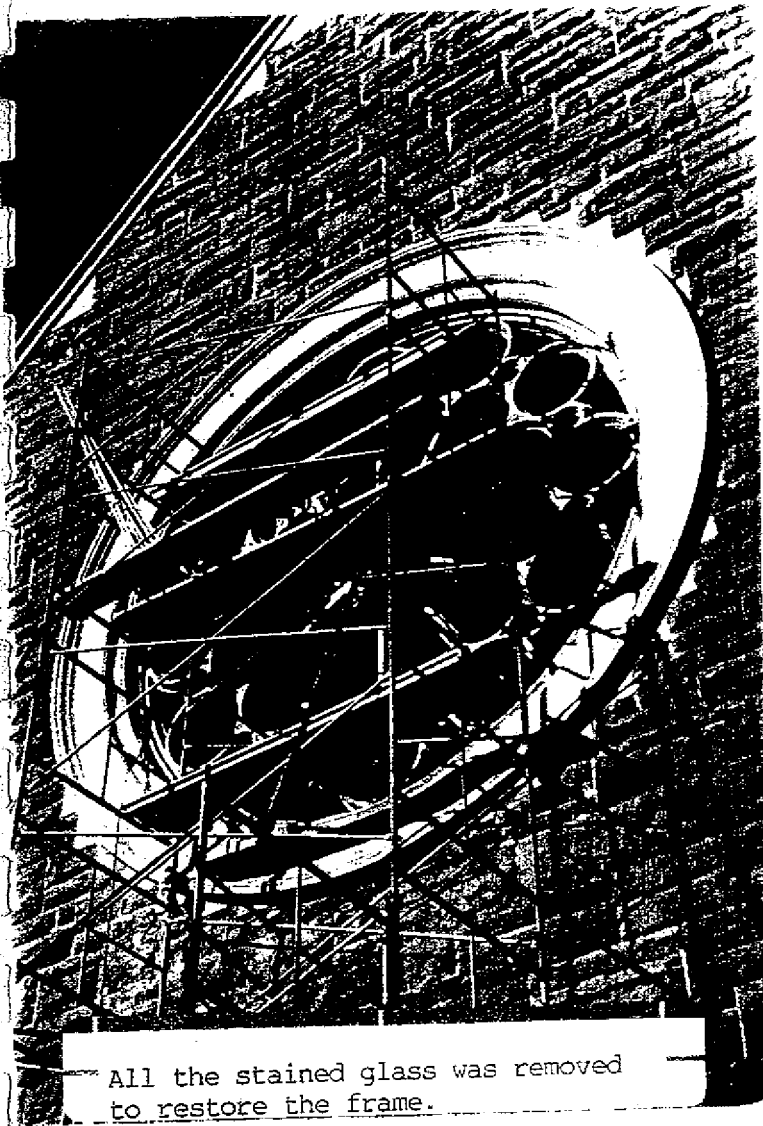
All the stained glass was removed to restore the frame.

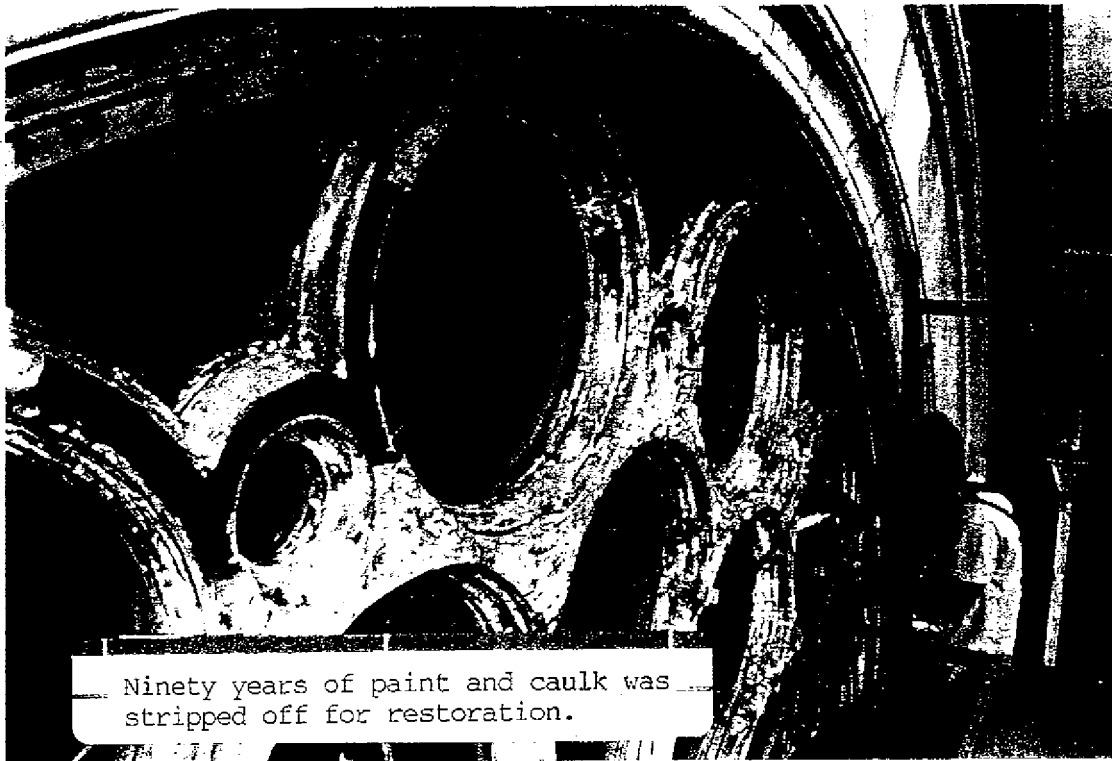
Ninety years of paint and caulk was stripped off for restoration.

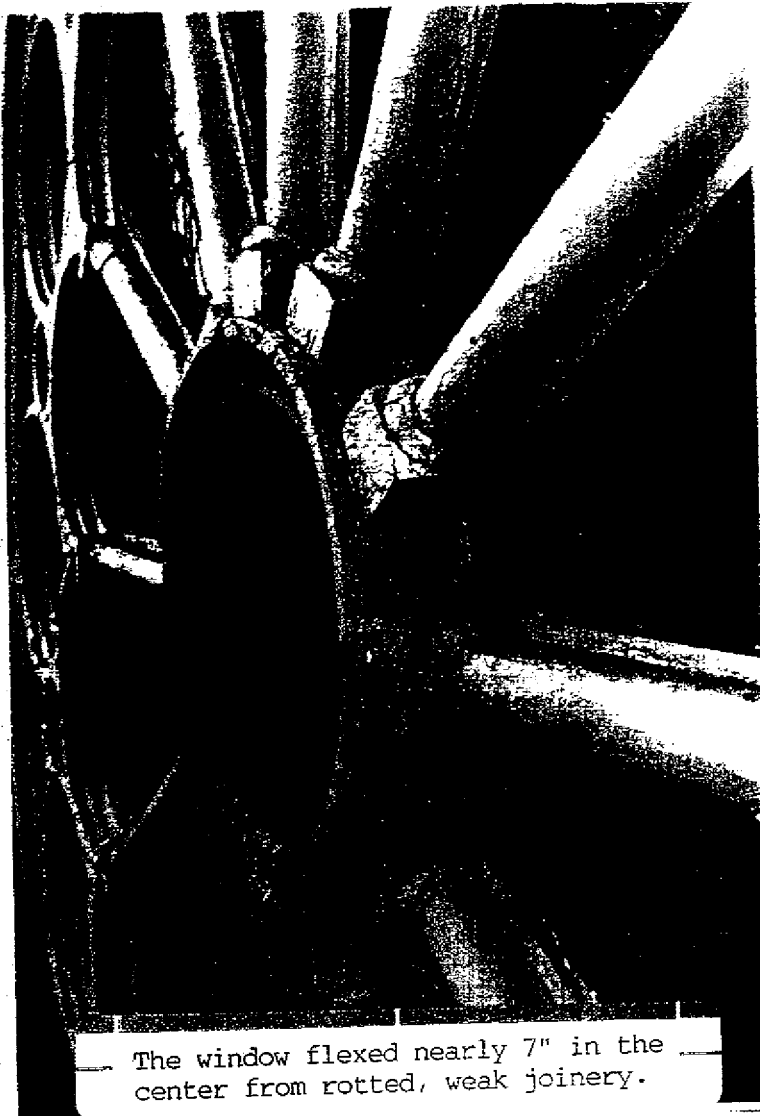
The window flexed nearly 7" in the center from rotted, weak joinery.

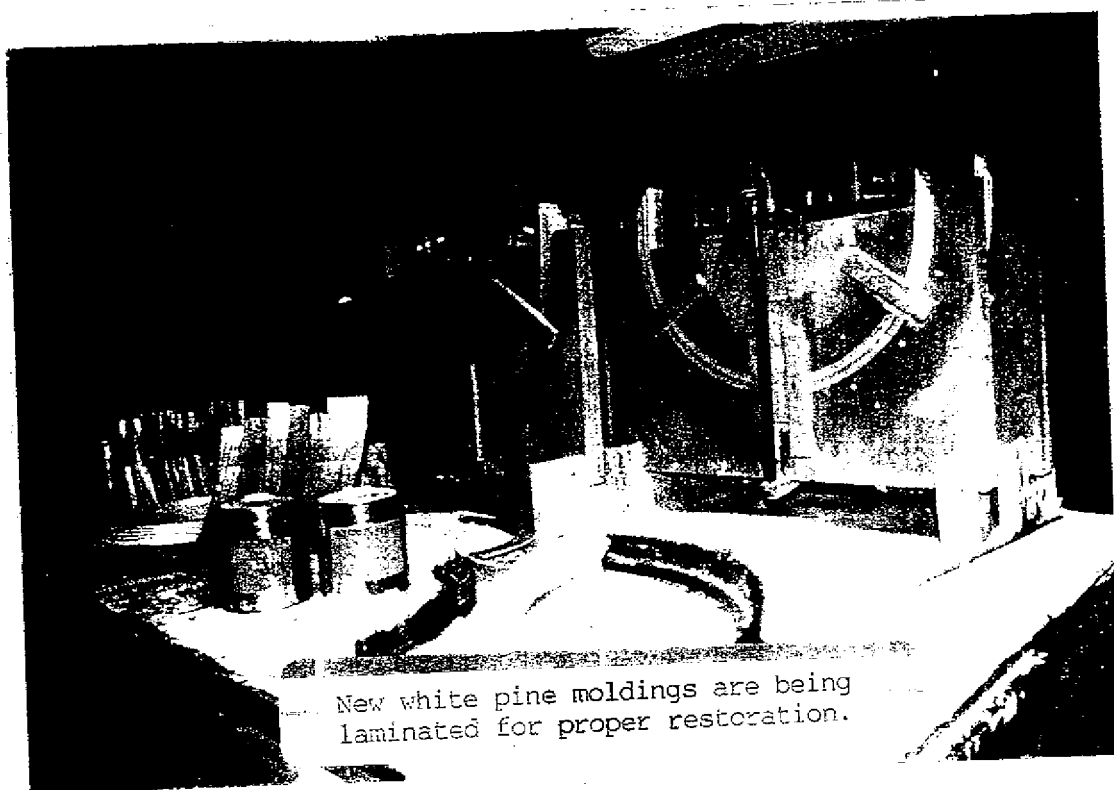
New white pine moldings are being laminated for proper restoration.

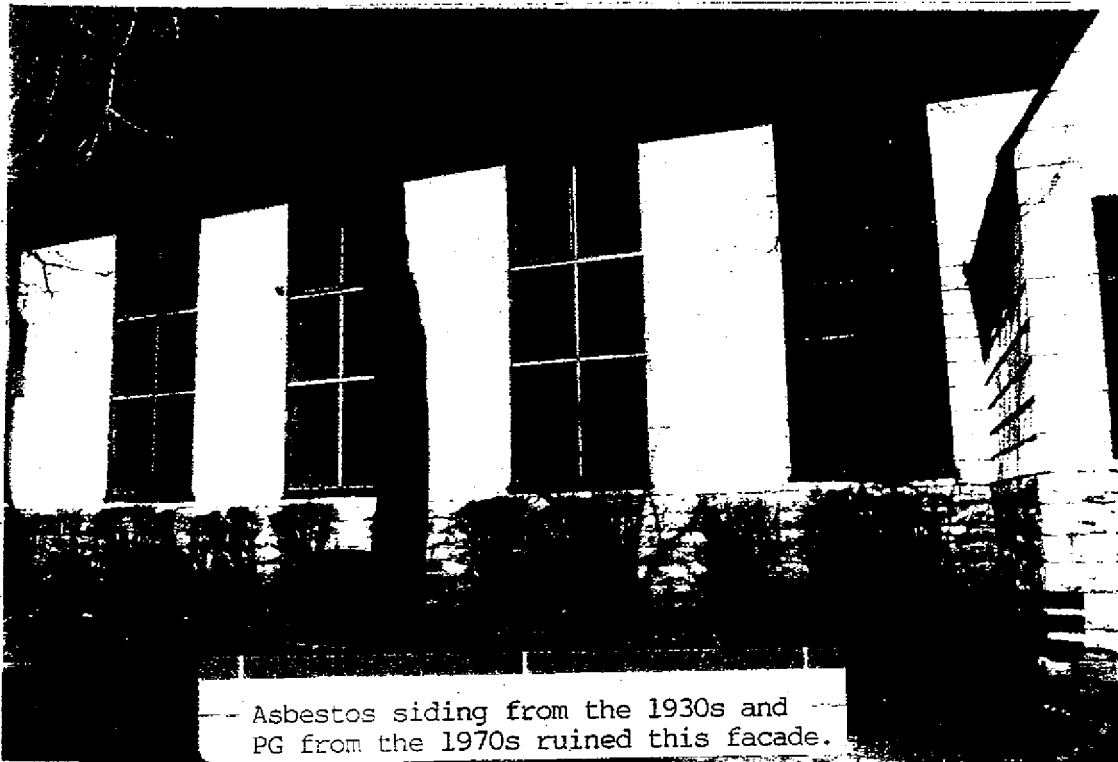
Asbestos siding from the 1930s and PG from the 1970s ruined this facade.

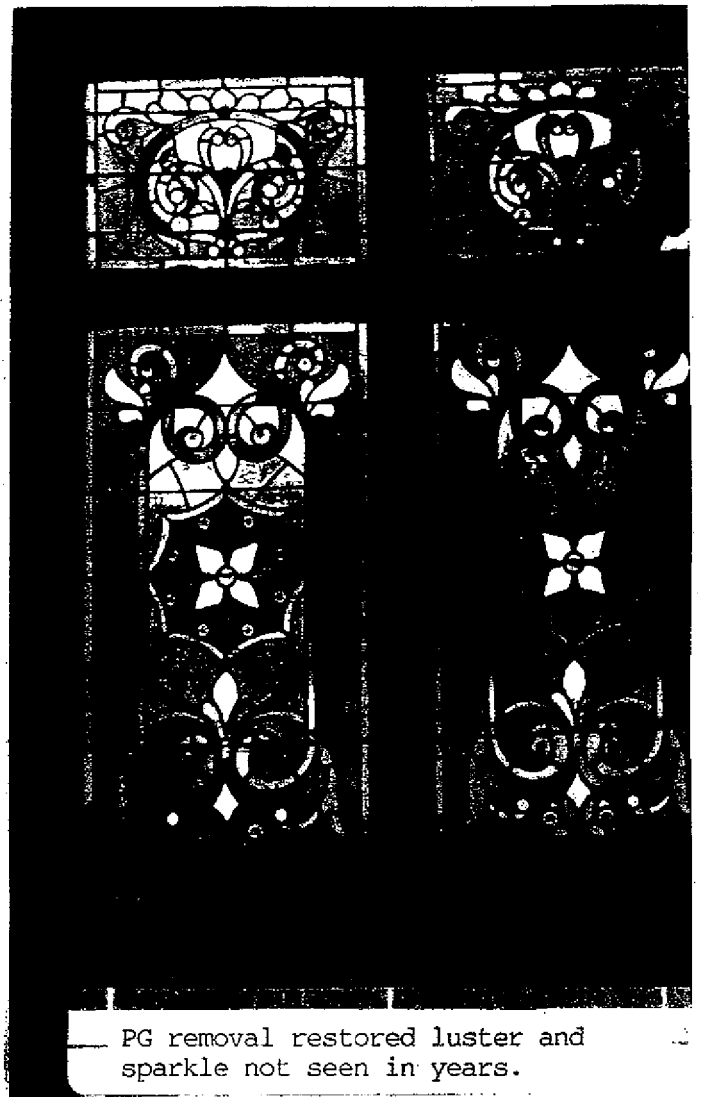
— PG removal restored luster and sparkle not seen in years.

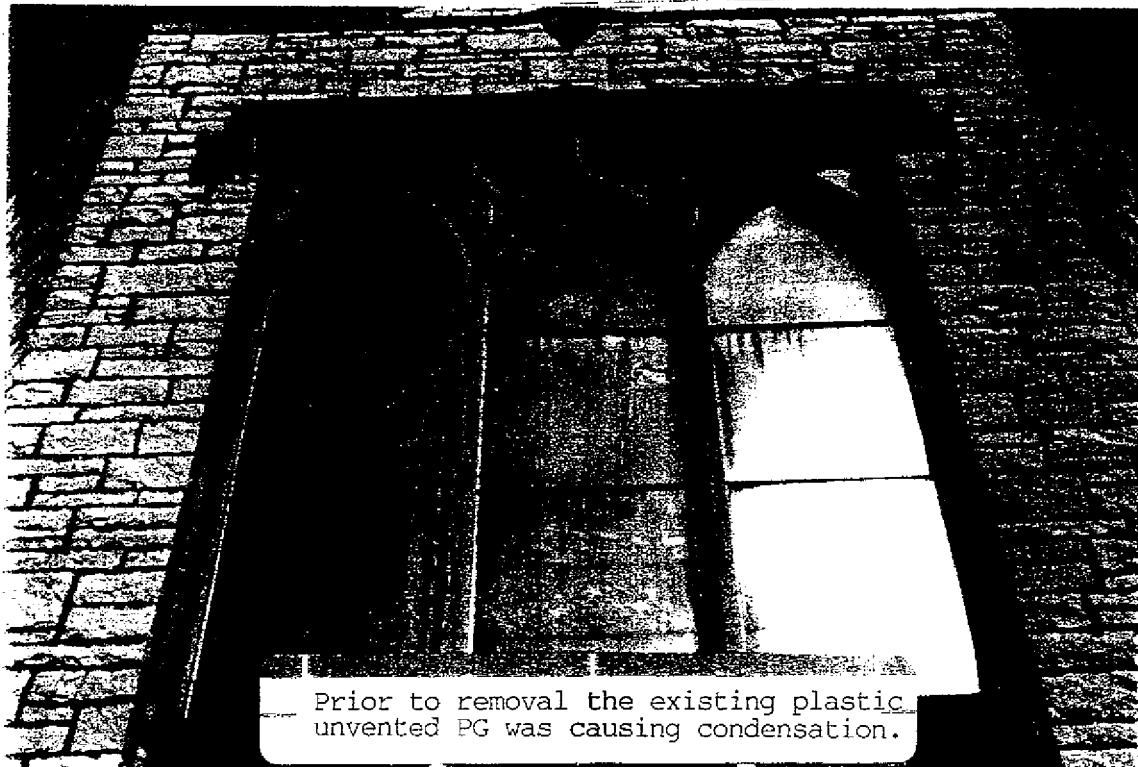
Prior to removal the existing plastic unvented PG was causing condensation.

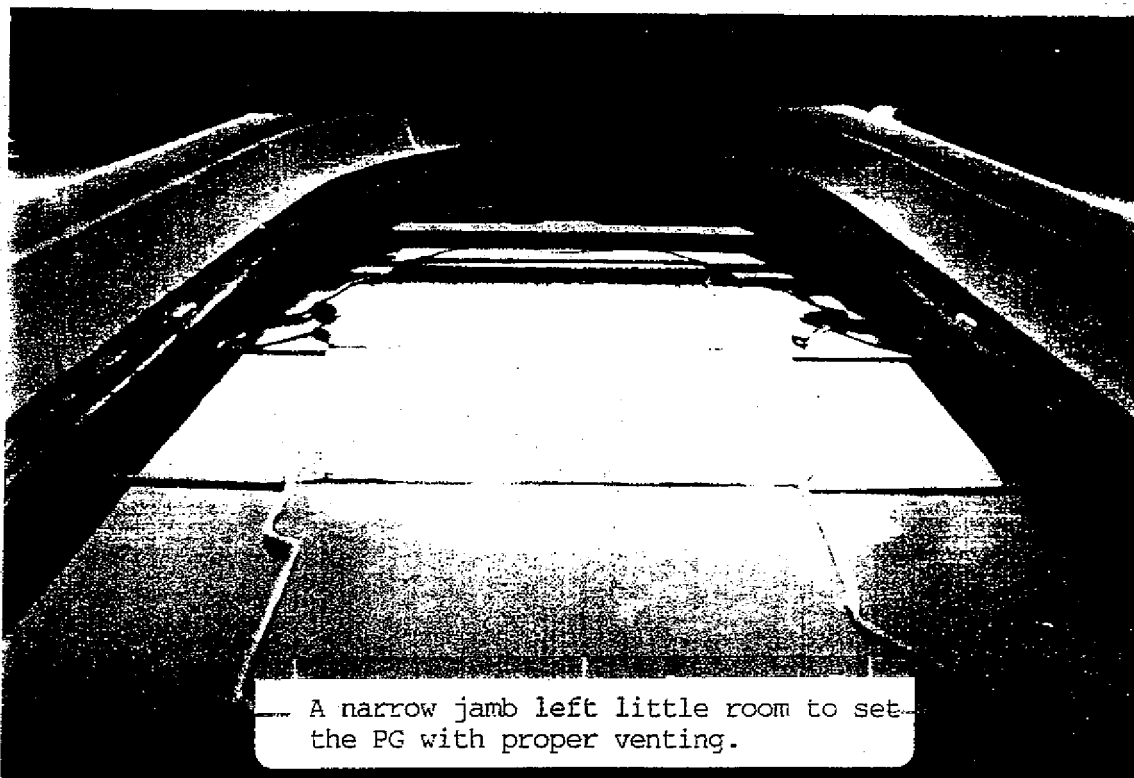
A narrow jamb left little room to set the PG with proper venting.

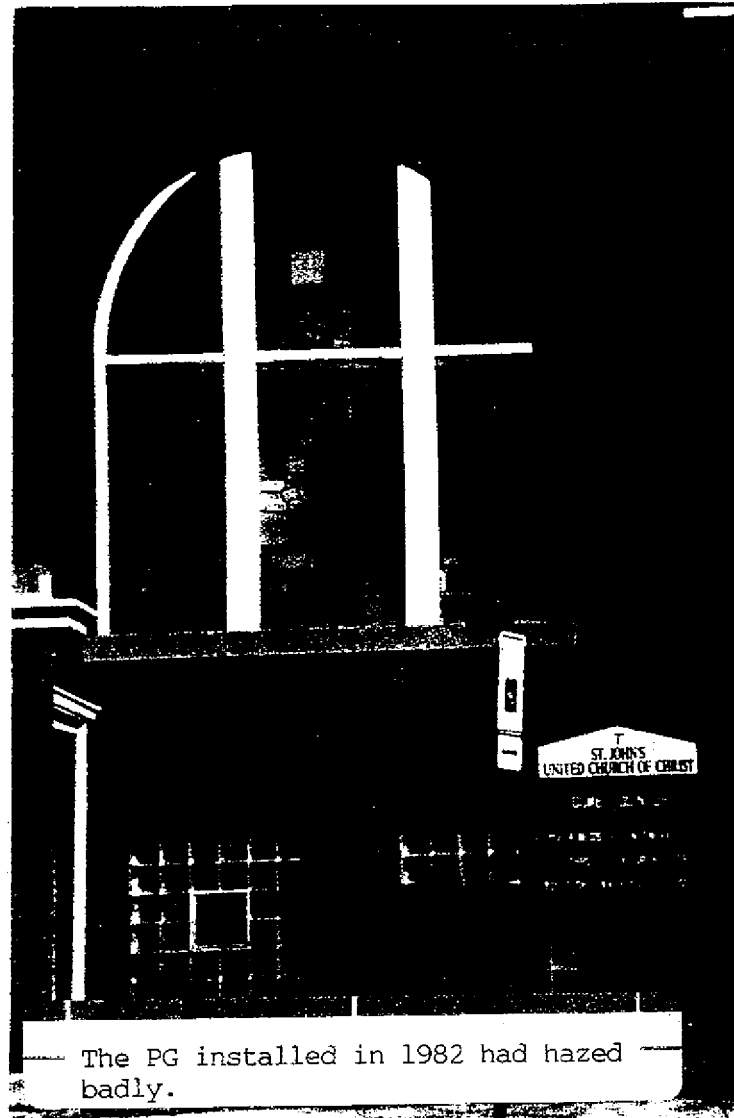
The PG installed in 1982 had hazed badly.

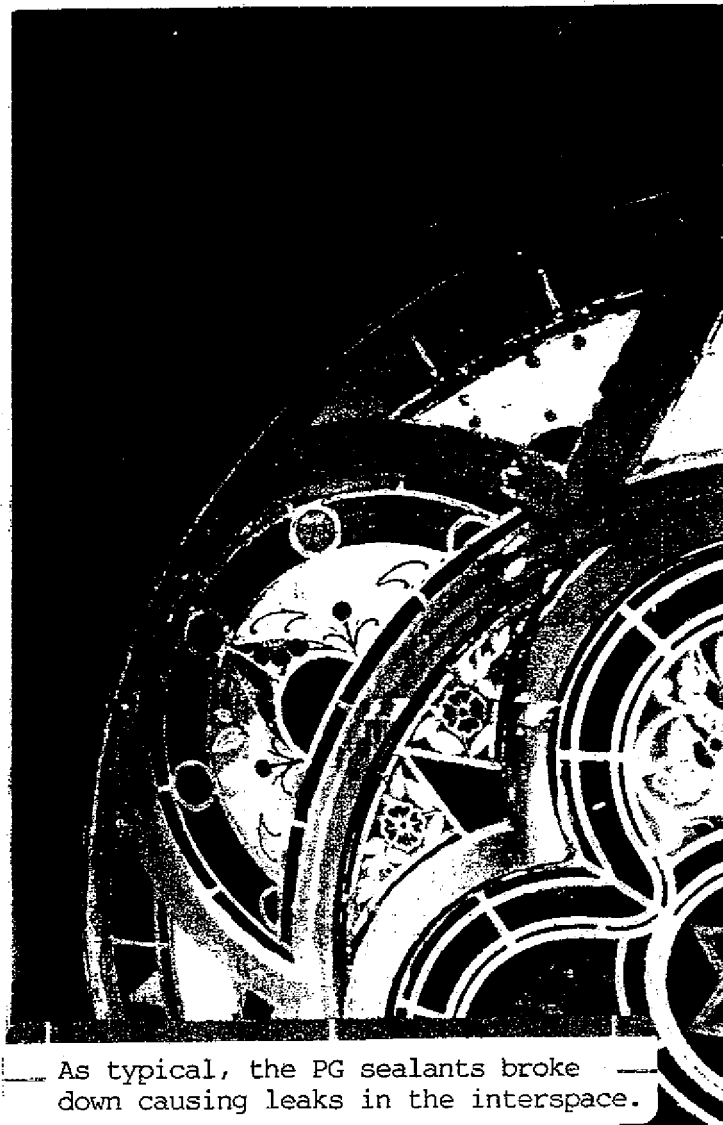
As typical, the PG sealants broke down causing leaks in the interspace.

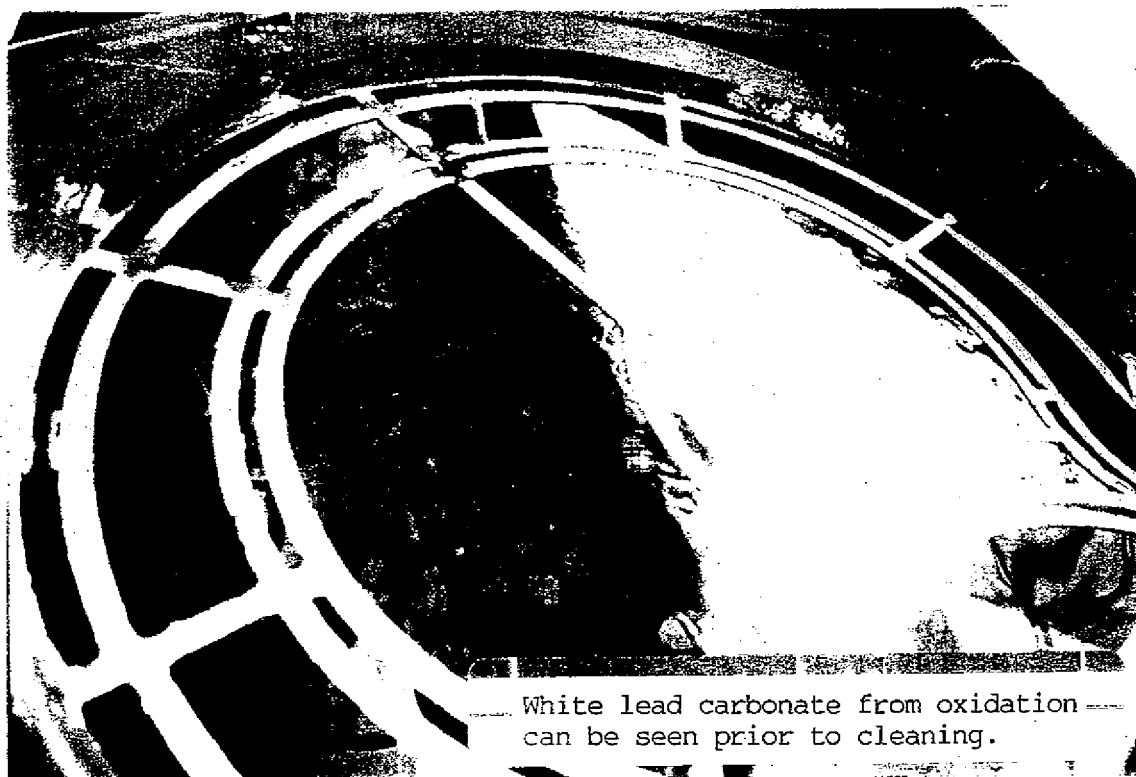
White lead carbonate from oxidation can be seen prior to cleaning.

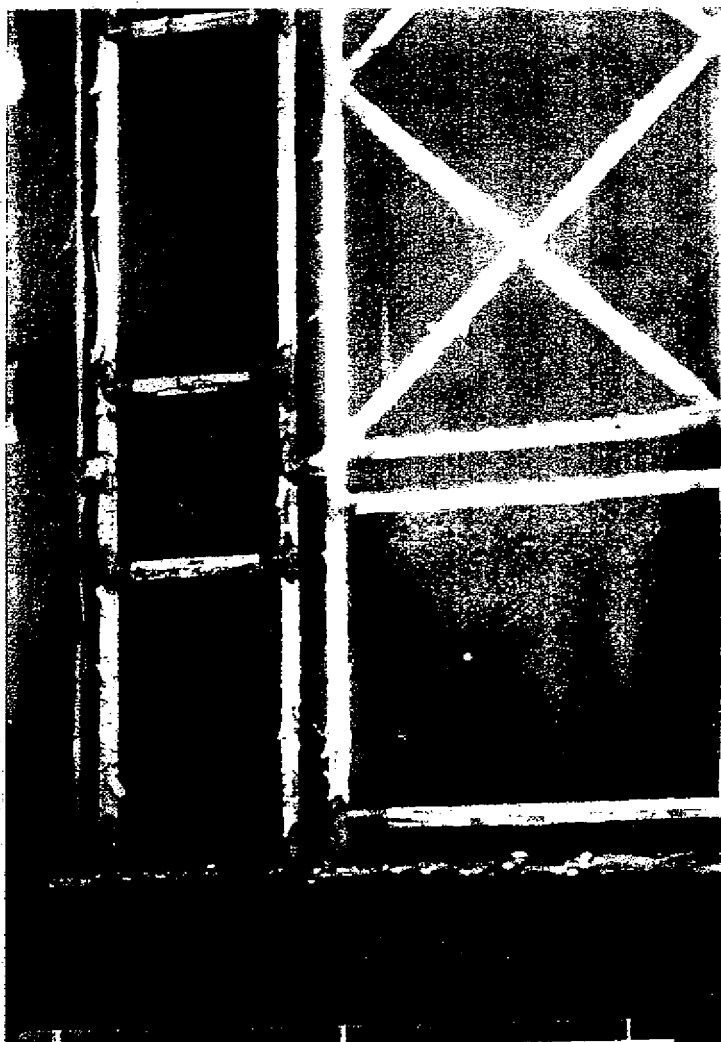
Lead carbonate was peeling off the window from condensation.

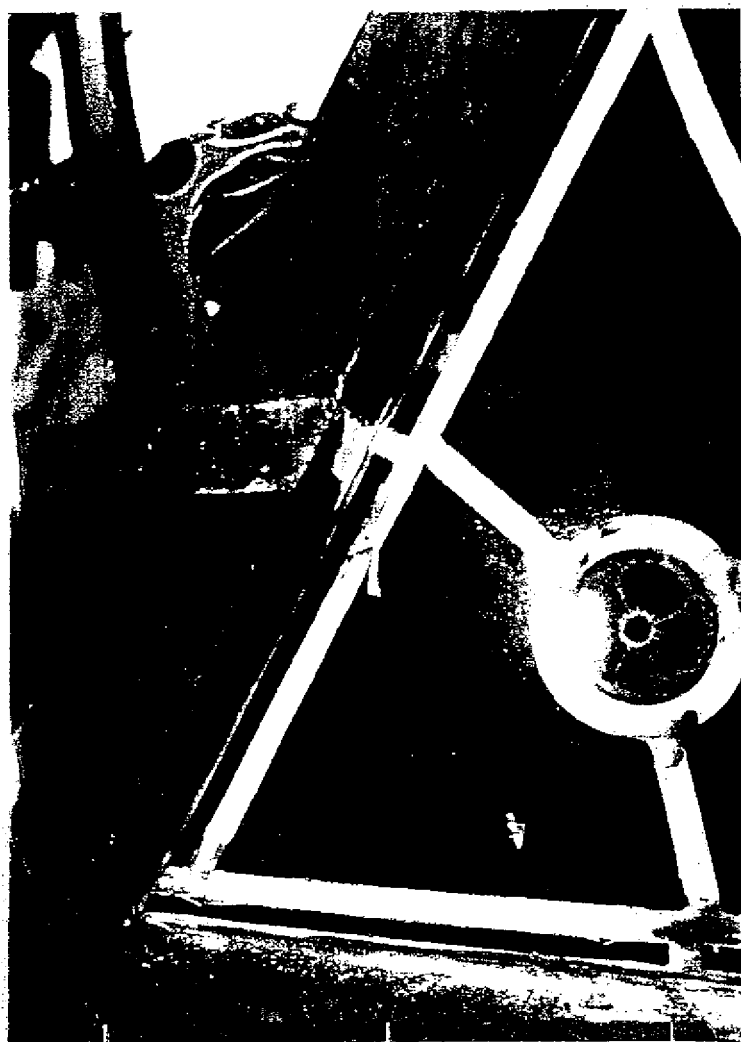
Lead carbonate, faded paint, and rotting wood caused by condensation.

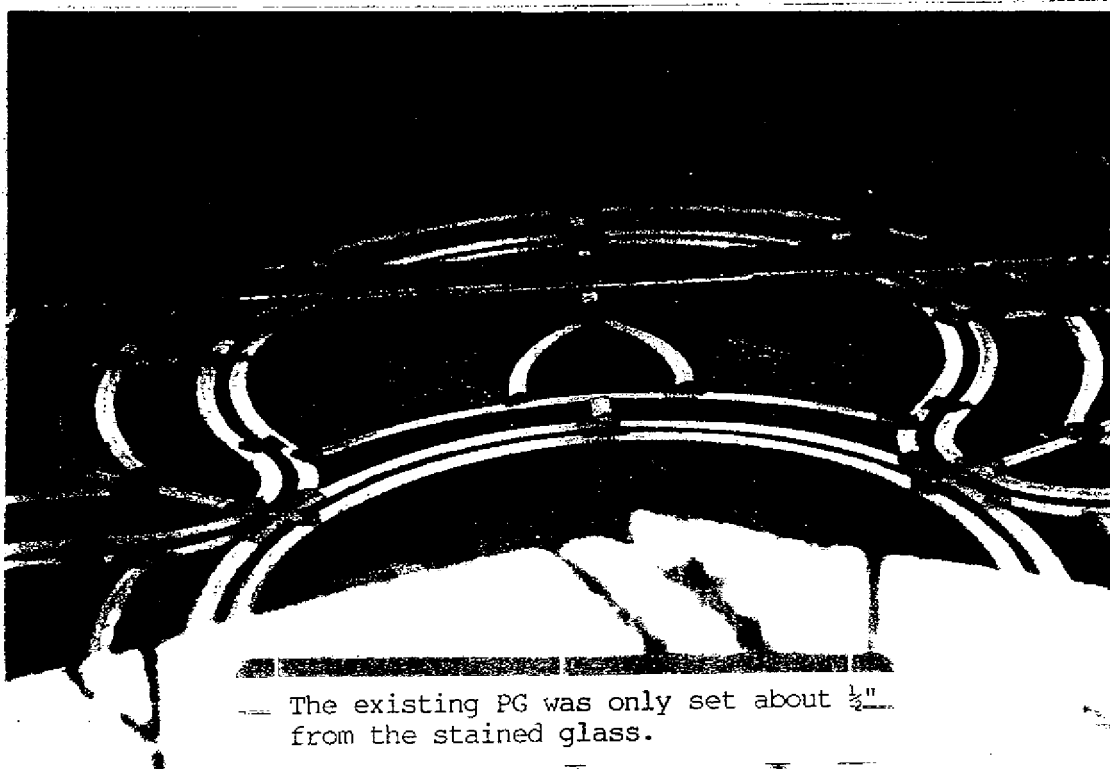
The existing PG was only set about $\frac{1}{2}$ " from the stained glass.
